Report on Tornado & Severe Thunderstorm 19, December 2009

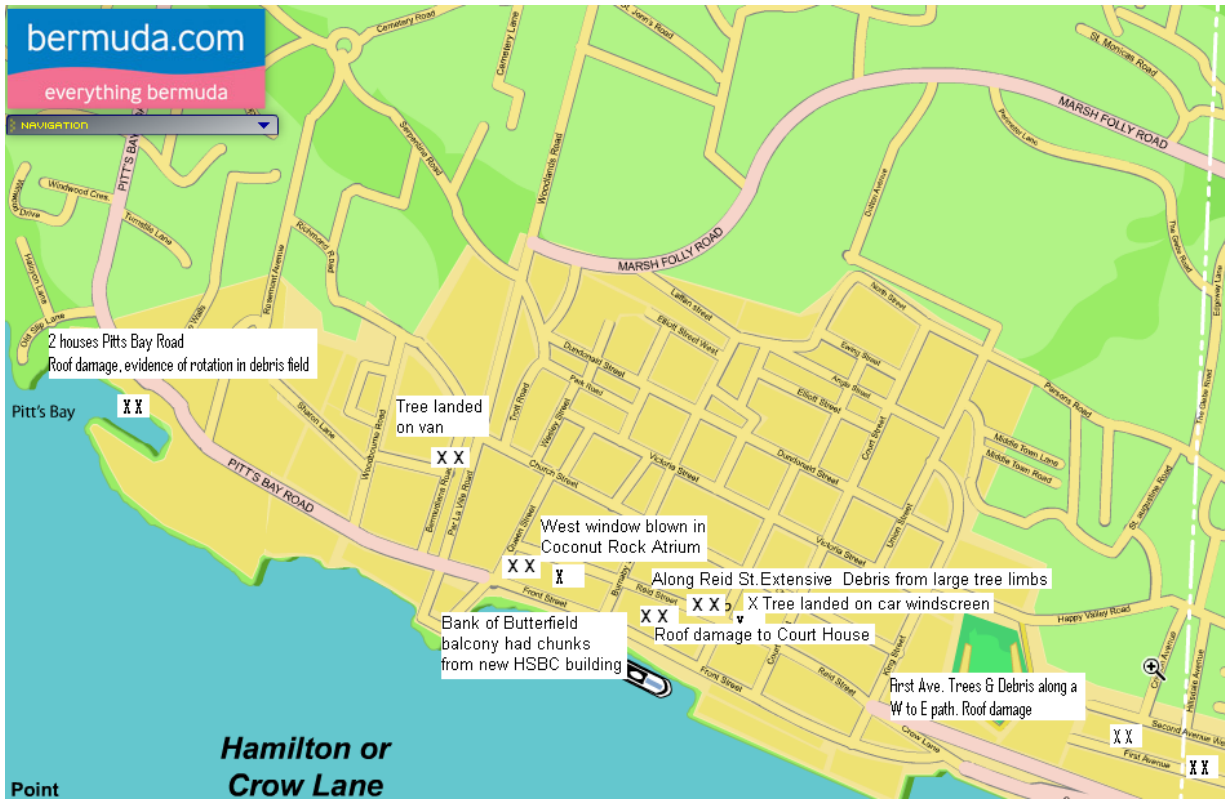
The conclusion based on our analysis of the Doppler radar data, the survey of damage and the input from various members of the public, is that this feature approached the northwest through north of Hinson's Island, came onshore at Pitts Bay Road as a tornado, travelled towards Reid Street, probably had a modified surface wind field due to the friction of buildings thus acted like a straight line wind even due to the tunnelling of the wind down Reid Street, as it hit Cavendish Heights it could have had rotation at that elevation (not certain as debris did not confirm this). It looks like the damage at Devonshire Bay was from a different thunderstorm cell based on the paths of the cells and timing of damage. This most likely was due to straight line winds as the debris is orientated in line with the forecast and observed wind direction, from SW to NE. It is difficult to judge the category of tornado due to the standard descriptions of damage being related to United States building structures, and Bermuda roof construction is extremely different. It would require less force to tear off a US style roof compared with Bermuda construction. As it stands I can estimate the tornado to have been between EF1 and EF2 due to these categories claiming "Heavy roof damage to homes and businesses, large tree limbs snapped off".

Figure 1: Path of suspected tornado and locations of resulting damage in Hamilton

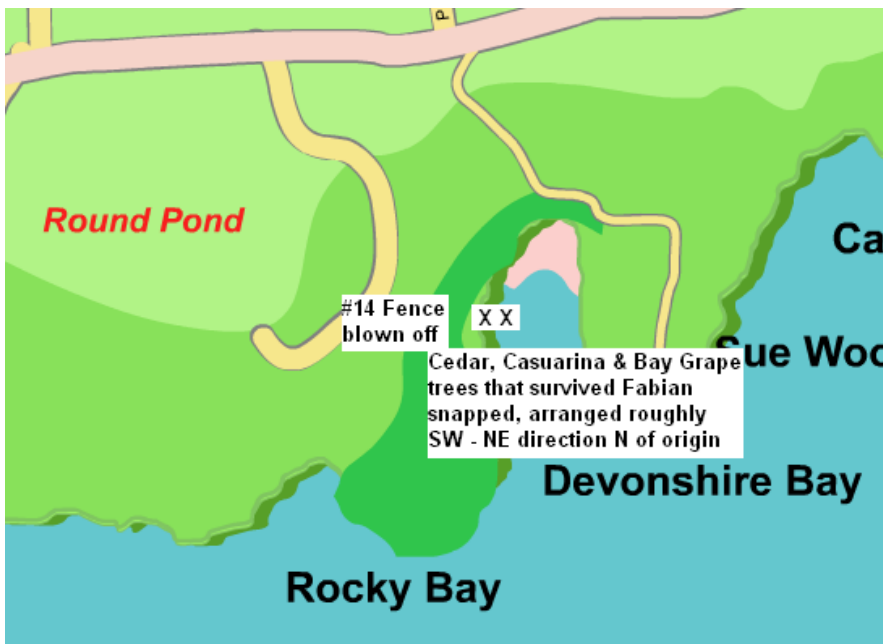
Figure 2: Path of suspected tornado and locations of resulting damage in Devonshire Bay

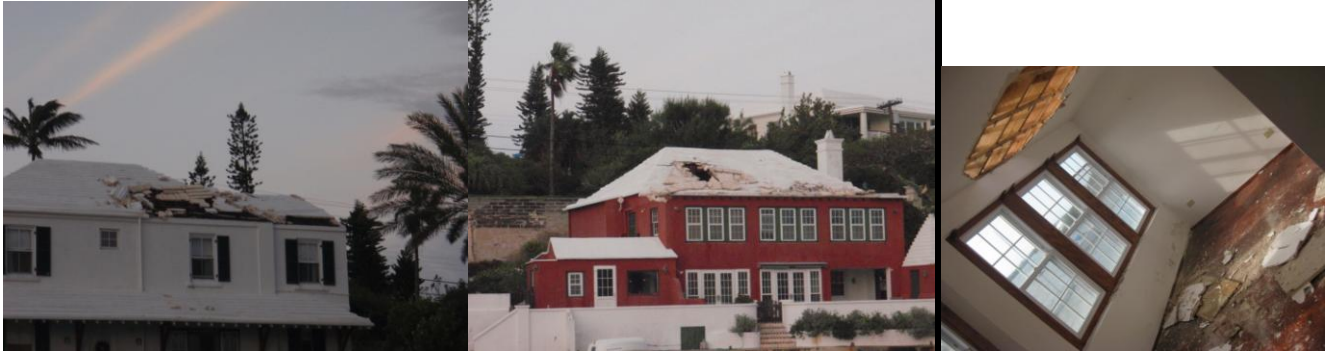
During Sunday 20th December further investigation was carried out along **Pitts Bay Road**, by the Deputy Director (figures 4 & 5). It was at these homes that evidence of rotation in the debris field was observed. Large chunks of the roof (not able to be picked up by a man) were found in an outside stairway approximately 20 feet W through NW of the origin. A straight line wind would have scattered the debris to the NE. A blind in the lee side of the red house was twisted off leaving a fraction of it still attached to a hinge (see photo). The push-out hook for the blind was located not only on top of the roof but south of the window of origin. Teak table and chairs on the S side of the house were scattered around the E through N side of the building. A large tree limb was oriented in a SE through NW direction. A quick glance at the weather sensor data from the Davis instruments on Hinson's Island showed a peak wind of 64 knots over a 5 minute time span around the time of the suspected tornado, and a rapid drop in pressure (see Figure 8.)

Figure 4: Roof damage at Pitts Bay Road, Hamilton, Pembroke

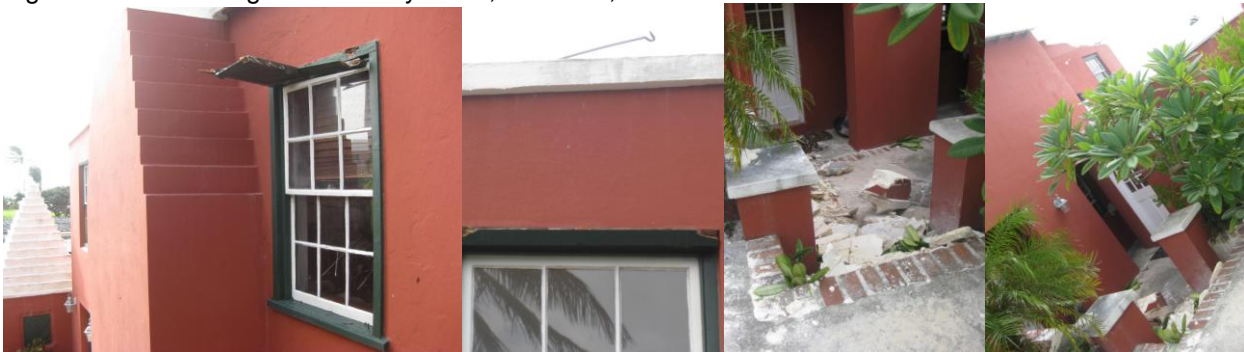
Figure 5: Evidence of rotation: torn blinds on the lee side of Pitts Bay Rd House, Blind hook found on TOP of house (behind and above original location), chunks of roof found 20ft SW of origin

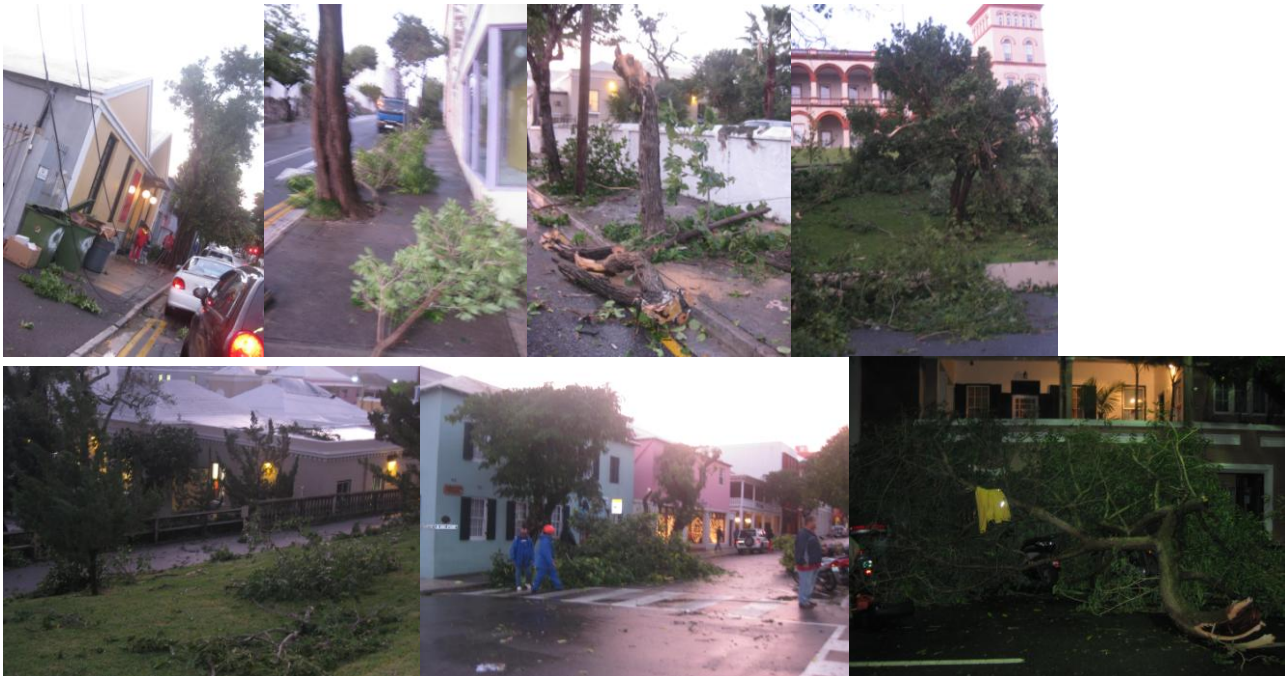
In the **City of Hamilton** the first evidence of damage were large limbs of trees strewn across Reid Street. (Figure 6.) Power lines were down outside of Chopsticks; the roof on the main entrance to Magistrates Court (corner of Parliament and Reid Streets) was damaged and covered by tarpaulin by the time we got there (around 5:30pm). Buildings Superintendent Stephen Tucker (Min of W&E) indicated that it was likely because of the impact of debris/missiles carried in the wind, rather than direct damage done by the wind itself. Pedestrians and motorists had dragged lots of large tree branches off the road and onto the sidewalks along Reid St, from Parliament St. to Burnaby Hill to enable traffic to flow through the city. However there were some that were too heavy to lift and thus were broken down into manageable pieces by chainsaw. Some large limbs had fallen onto bikes, knocking them over, or otherwise trapping them and making them inaccessible to their owners to remove. There were unconfirmed reports of parked bikes on Reid St. being scattered by the wind, and two cars being heavily damaged by tree branches (one by the General Post Office), but not in evidence when we got there (perhaps towed/driven away already). The building next to Chancery Lane had some roof damage (20 X 5 feet according to high-lift & truck operator, who was assisting in the securing of the roof). Apparently the area around Joell's Alley took some damage also (unconfirmed). The Coconut Rock building had one pane of their west-facing atrium windows (top floor) blown/impacted in. Later we had a witness contact us to say that there was damage to the new HSBC building under construction and that the debris landed on top of the Royal Gazette building and the balcony of the Bank of Butterfield.

Figure 6: Fallen Tree Limbs, Reid Street, Hamilton, Pembroke

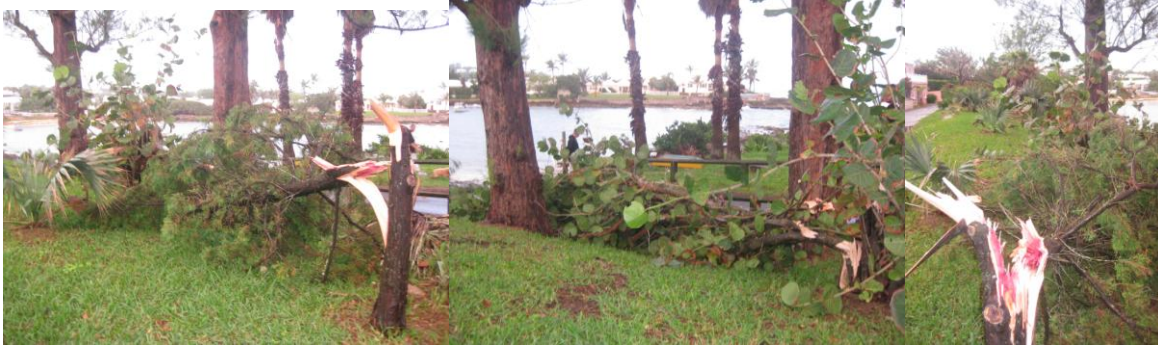
At **Devonshire Bay** several tree branches were blown down (figure 7), all facing the same direction, NNE from the point of origin. A small cedar tree was snapped off three feet from the base. Minor structural damage occurred as a fence was blown off at 14 Devonshire Bay Rd. The residents of #14 mentioned that the casuarina trees affected by this wind damage had withstood several hurricanes, including Fabian. This evidence supports the idea of a large short-term increase in wind speed (i.e. the suddenness of a squall or a microburst).

Figure 7: Fallen Trees, Devonshire Bay, Devonshire
